NPDES Compliance Inspection
Hot Springs Lagoons

Date: July 16, 2014

Permit No.: MT0020591

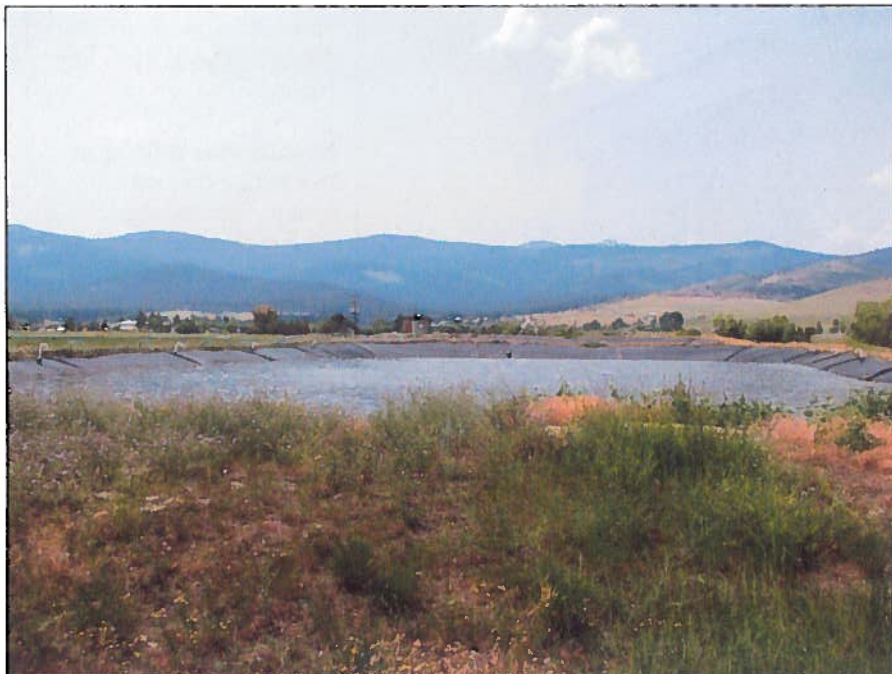
Photo 1:
Taken by David Rise,
July 16, 2014.

Overview of the Hots
Springs lagoons, looking
west from near the
chlorine building.

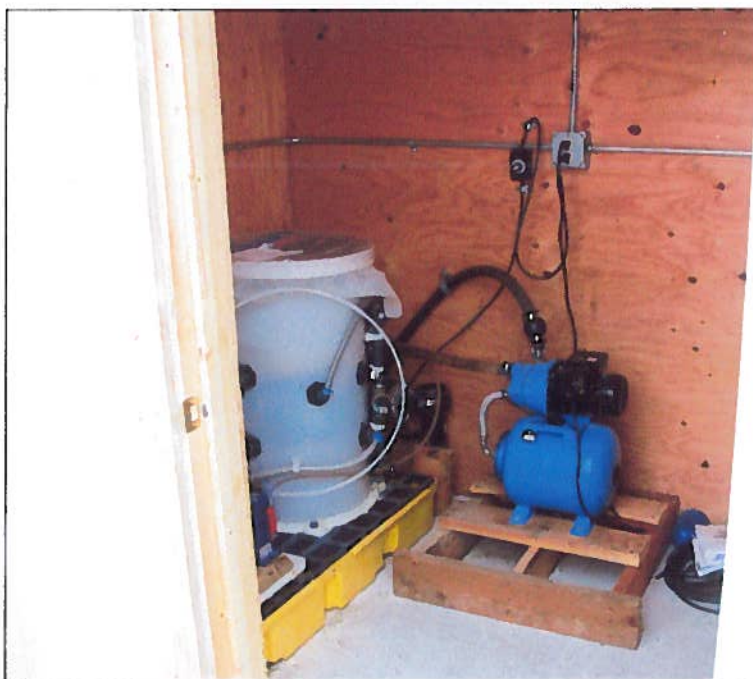
Photo 2:
Taken by David Rise, July
16, 2014.

Looking into the new
chlorine building at the
Hot Springs lagoons.
Chlorine tank and injector
pump.

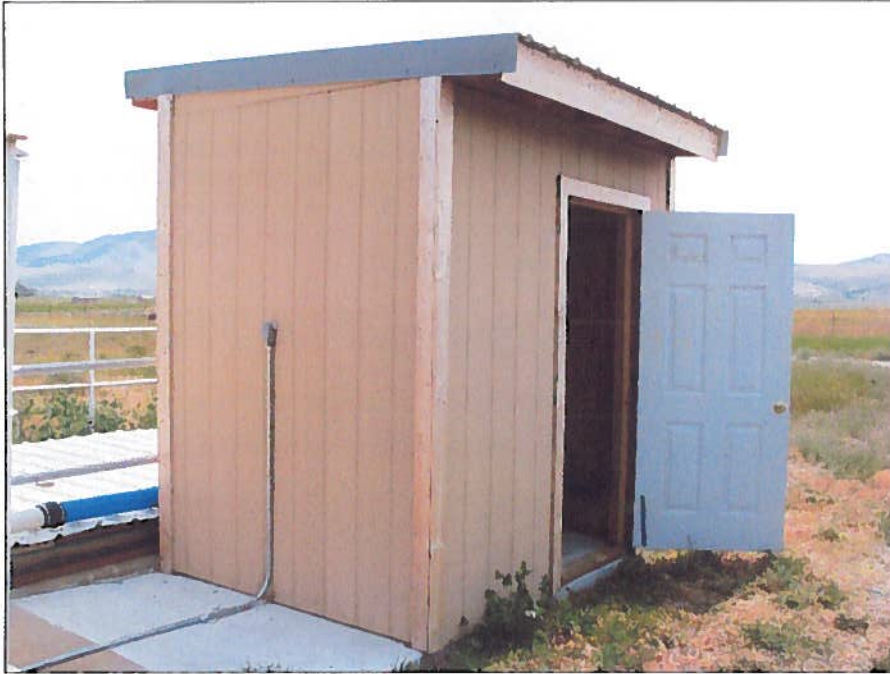
Photo 3:
Taken by David Rise, July
16, 2014.

New chlorine building at
Hot Springs lagoon
system. The chlorine
contact chamber is visible
behind the building on the
left side of the photo.
